# ENTERPRISE HOUSE DARLINGTON LTD

## Asbestos Management Plan

**Property:** Enterprise House

**Address:** Valley Street North: Darlington DL1 1GY

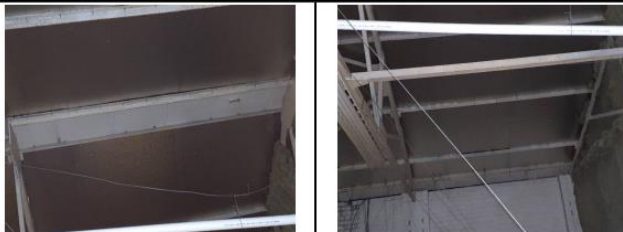
| Item Description: Fibreboard panels - Roof above suspended tiles | | | | | |
| Sample Comments: Centre and perimeter of roof. Presumed as unable to reach due to height restrictions. | | Extent:<br>30lm | | | |
| Extent of Damage: | Low Damage | 1 | | | |

| Maintenance activity | Average Score | 0 | Recommendation: Inspection Required Prior to Disturbance (Further sampling/analysis) | | |
